## HYDROSTATIC DRIVE OF THE FERRY APPROACH BANK

**Summary.** The operating problems of the ferry approach ramp have been presented in the paper. The incorrect idea of approach bank drive system and abnormal operator acting, have been both the reasons of break-down and damage of a ferry terminal. The evaluation of the run of events and finding the reasons of the failure, have been possible thanks to the analysis of drives and control systems.

The expertise, discovering the reasons of the ferry terminal approach bank in Gdynia has been done by the Chair of Working Machines, Drives and Control in 2006. The main objective of the expertise was the investigation of damage sequence and discovering the reasons of damages.

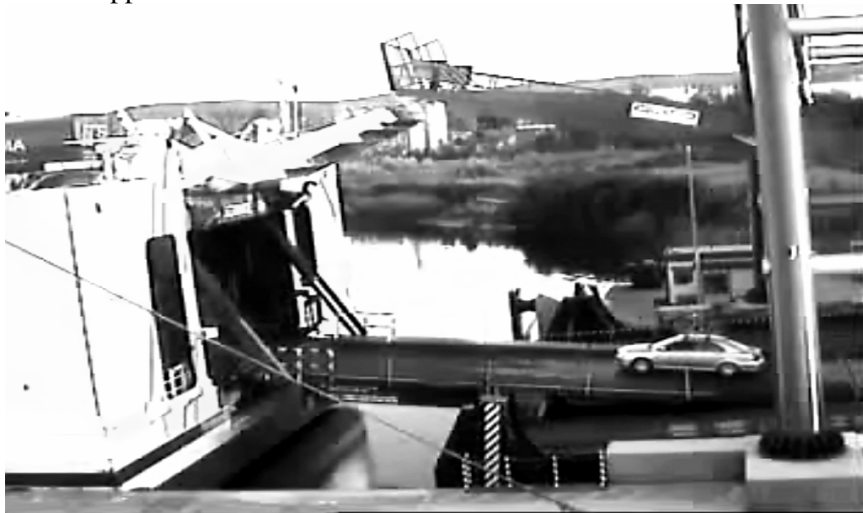
In the fig. 1, which is one of the frames from the film presenting the terminal operation, it can be seen that the requirement mentioned above is not respected by the ferry operators. To reduce the time they started to hoist the upper ferry ramp before finishing the movement of the approach bank of the terminal. At the beginning of expertise works it has been assumed as the main reason of the damage. This assumption was done because during the incident, earlier hoisting of the ferry ramp hooked up the not finally hoisted approach bank.

Fig. 1. Dangerous close proximity of the ferry ramp with the approach bank  
Rys. 1. Niebezpieczne zbliżenie ramy promu do pomostu

On the basis of the operational film analysis it has been discovered that always in practice the hoisting of ferry ramp had begun before the ending of approach bank hoisting. It can be observed that the beginning of the ferry ramp hoisting took place when the position of the hoisted approach bank was about 40 – 56% comparing to its final destination. Usually it did not cause any failures however on the day of the accident when the ferry ramp came into collision with the being hoisted approach bank.

It was also recommended to use the close proximity sensors on the ferry ramp in case of the ferry ramp hoisting before ending the approach bank hoisting (which reduces the time of ferry loading of about 1 minute).

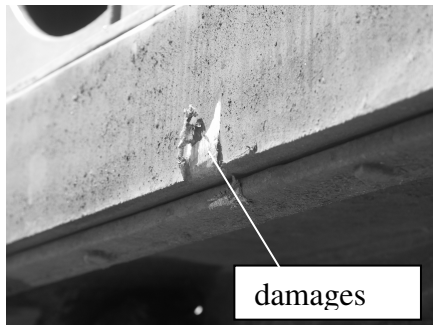
The accident resulted in damages of some construction elements and sliding surface of the hydraulic cylinders. For example fig. 2 and fig. 3 shows damages of the approach bank edge and lock support. It means that when being hoisted, the approach bank has been deformed (turned) in this way that the collision of the support placed on a fixed steel construction with the stay of the right hydraulic cylinder took place.

Fig. 2. Damages of the approach bank strip and flap  
Rys. 2. Uszkodzenia listwy pomostu i kłapy obrotowej (flapa)

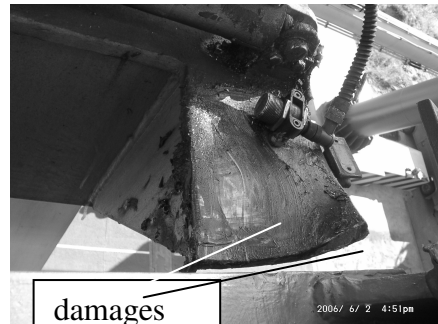
bank and ferry ramp, have been determined. The geometrical limitation of the hydraulic cylinder displacement in the plane of its axis limited by the axial play has been determined as well. It was done because the damages of the hydraulic cylinders piston rods' sliding surfaces showed that the cylinders had not been fixed correctly and had been bended during approach bank hoisting in the day of the incident.

Fig. 3. Damages of the lock and cylinder support  
Rys. 3. Uszkodzenia podpór rygla i siłownika

The responsibility for cylinder damages was the responsibility of the operator and constructor of cylinders' supports who unnecessarily limited the range of their joined support. The responsibility for damages of cylinder and lock support was the operator who did not behaved rightly with attention and care during the manual controlling of the approach bank hoisting. The responsibility for the approach bank support's strip damages takes the ferry ramp operator who has started the ferry ramp hoisting too early, ignoring the technical and operational instructions of the ferry terminal documentation.

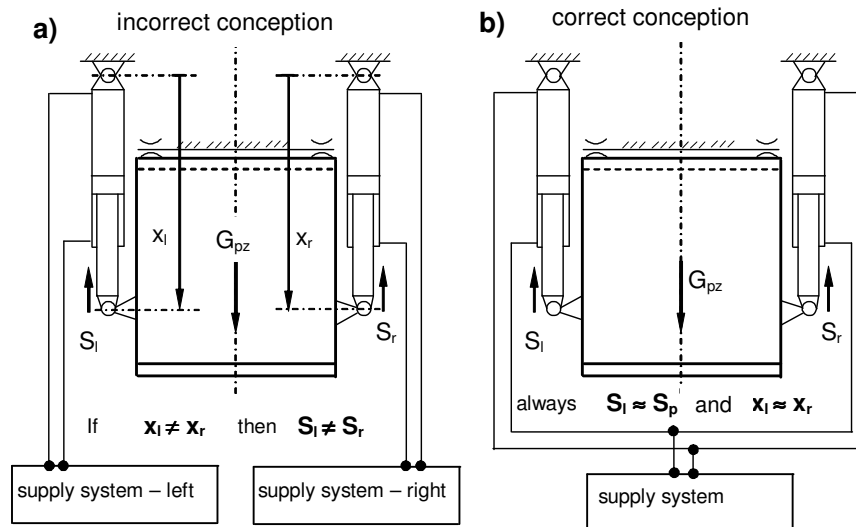
In fig. 5 schemes of both, used and correct conception of the approach bank driving systems are shown.

Applied solution conception of hydrostatic drive approach bank shown in fig. 5a has been recognised as incorrect for reasons as follows:

- forces  $S_1$  and  $S_p$  of hydraulic cylinders can be different in values resulting from the deviation of displacement and position sensors accuracy. Practically the approach stage will always be turned during the hoisting and lowering until the loosening of cylinder chambers after putting down of the approach bank on the ferry ramp,
- operation of ferry station requires very special operator's attention because the failure of regulation system can lead to serious damages of approach bank and hydraulic cylinders,
- individual supply of hydraulic cylinders with position regulation demands complicated control and regulation systems with many valves and sensors putting down to climatic stress and

In case of sufficient torsional rigidity of the approach bank and of a small difference of external forces' values the conception shown in fig. 5b should be taken into the project of drive system hoisting.

This system is much simpler, cheaper and has bigger operational reliability and safety. The autonomous synchronisation of piston moving rods and loss of pressure after putting down the chamber bank on ferry ramp takes place in a simple way.

Fig. 5. Scheme of incorrect a) and correct b) conceptions of building approach bank driving system  
 Rys. 5. Schematy niewłaściwej a) i poprawnej b) koncepcji dla budowy układu napędowego pomostu stacji

It was temporarily recommended to lower the limit of supply pressure in the pumps line and the usage of more extensive signalling concerning incorrect position of cylinders piston rods during manual control. The suggestion of drive and control system change to the system which has been presented in fig. 11b has been recommended into recognition as well. It guarantees higher simplicity and reliability and immunity of driving system against operators' mistakes.

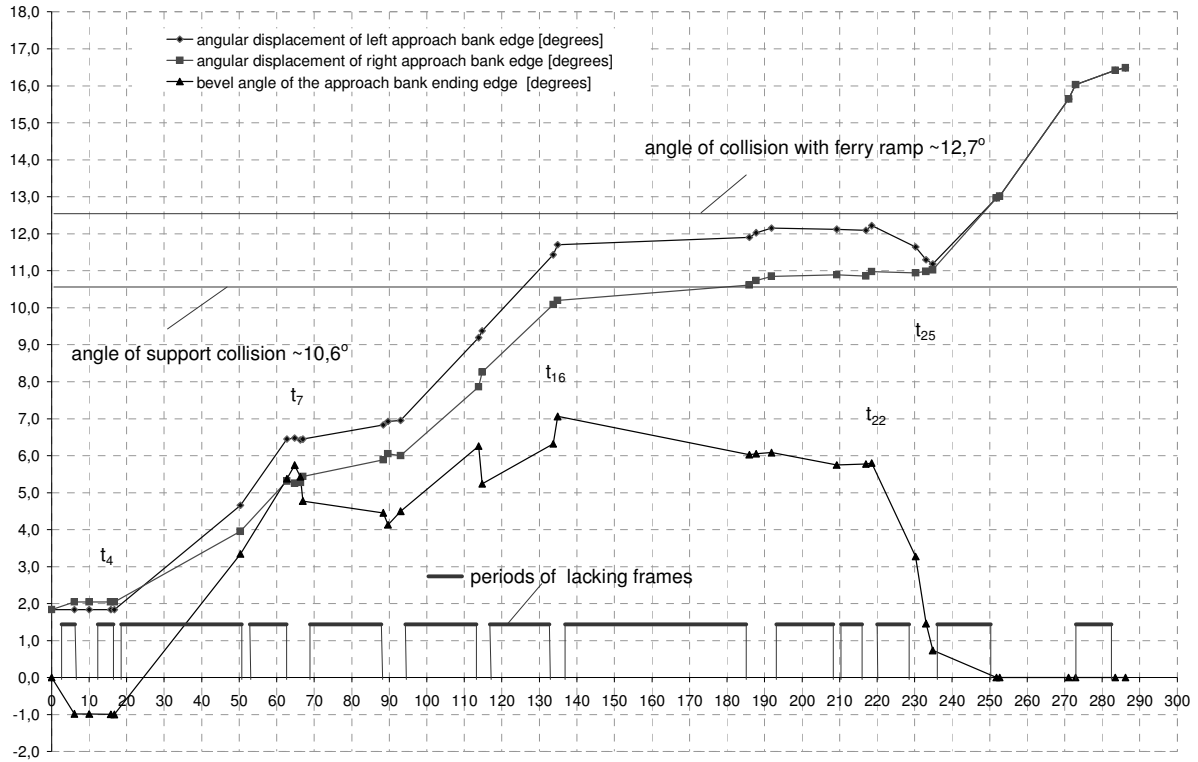
In the fig. 6 diagrams of left side -  $\varphi_l$  and right side -  $\varphi_p$  turn angles of the approach bank edge and bevel angle -  $\theta_k$ , of the its ending edge are presented. The collision position angle of the approach bank right side calculated on the basis of geometrical analysis is shown in this figure as well.

The hoisting of the approach bank has started only with the right side of the bank and next the movement has been stopped for about 11 second. Probably the automatic control system was not active and the operator switched to manual control. At this kind of control the left and right sides were non-uniformly hoisted and the bevel angle of the approach bank ending edge reached its maximal value in the moment  $t_7$ .

This process proceeded for about 48 s. Next, during about 154 s, some changes of the approach bank ending edge bevel angle can be observed till the moment  $t_{22}$  and in the moment  $t_{16}$  this angle had reached the maximal value. Nearly after this moment the collision of the right cylinder support with lock support had taken place and the approach bank movement was stopped for about 1,5 minute till the moment  $t_{22}$ . After the moment  $t_{22}$  during about 18 s the levelling of the approach bank left and right side positions took place by means of left side lowering at the stopped movement of the right side.

Fig. 6. The diagrams of the approach bank left and right side turn angles and bevel angle of the approach bank ending edge

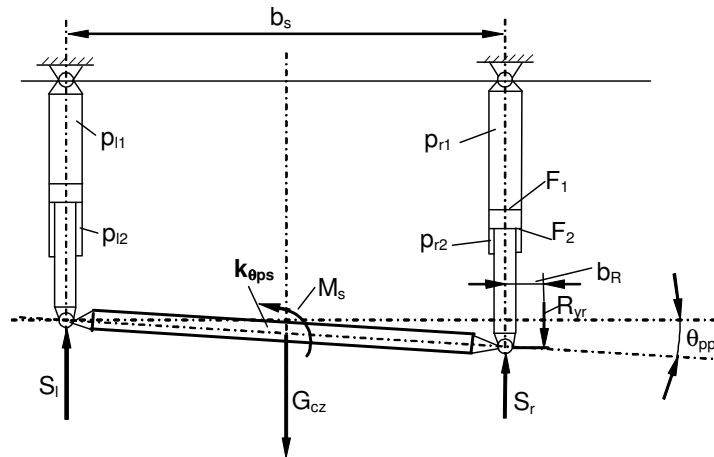
The diagrams of hydraulic cylinders' forces during the hoisting of the approach bank have been done by means of deformation analysis. For example, the system of forces acting on the approach bank at the moment when the right cylinder support collides with the lock support is shown in fig. 7.

Fig. 7. Forces acting on the approach bank in the moment of supports collision

Forces  $S_l$  of left and  $S_r$  of right cylinder are determined by the equations as follow:

$$S_l = \frac{G_{cz} \cdot 0,5b_s \cdot \cos[0,5 \cdot (\varphi_{pl} + \varphi_{pp})] - R_{yr} \cdot (0,5b_s + b_r) + k_{\theta ps} \cdot \theta_{pp}}{b_s} \quad (1)$$

$$S_r = G_{cz} \cdot \cos[0,5 \cdot (\varphi_{pl} + \varphi_{pp})] - R_{yr} - S_l \quad (2)$$

where:  $G_{cz}$  – force of gravity reduced to the plane of cylinders acting,  $b_R$  – distance between the support reaction force and the cylinder axis,  $R_{yr}$  – support reaction force calculated on the basis of the metal plate plastic strain deformation,  $\varphi_{pl}$ ,  $\varphi_{pp}$  – position angles of approach bank left and right sides,  $\theta_p$  – bevel angle of approach bank in the cylinder plane,  $b_s$  – cylinders distance,  $k_{\theta ps}$  – torsion rigidity of the approach bank in the cylinder plane.

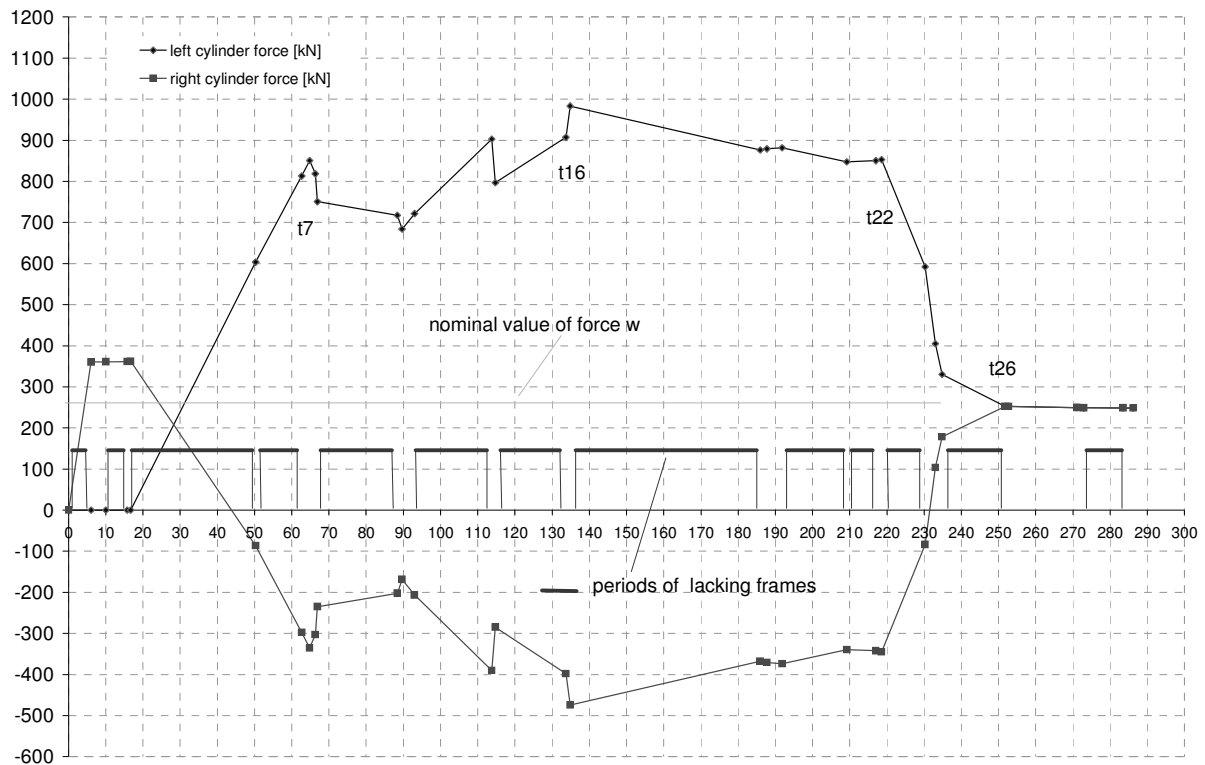
The diagrams of forces acted on the approach bank by hydraulic cylinders are presented in fig. 8.

Fig. 8. The diagrams of hydraulic cylinders forces  
Rys. 8. Przebiegi sił siłowników hydraulicznych

Big differences between forces in the left and right cylinders as a result of their non-uniform movement causing approach bank steel construction torsion are seen in this figure. About the moment  $t_{16}$  the left cylinder force reached the value close to maximal as a result of supply line pump pressure.

In the long period of hoisting, the force of the right cylinder takes opposite sense in comparison with the sense of the left cylinder force. It shows the approach bank had being turned by the drive system. Forces in cylinders equalize at the ending of the analysed period taking nominal values.

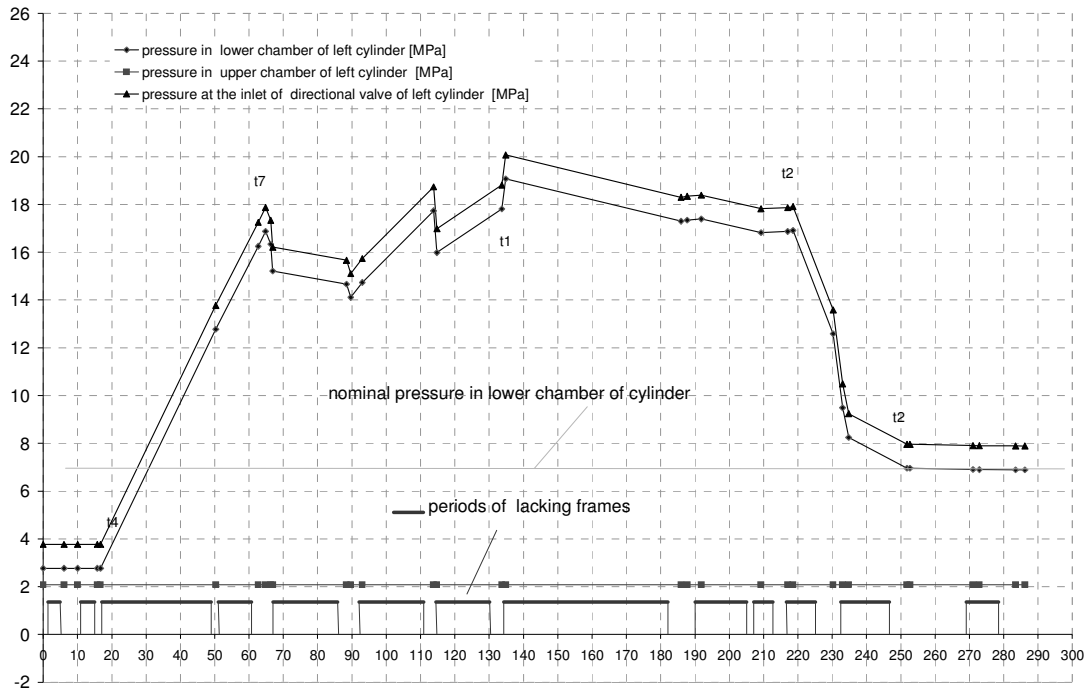
In the figures 10 and 11 appropriate diagrams of pressures in the cylinders chambers for work period of the ferry station are presented:

Fig. 10. The diagrams of pressures in chambers of the left cylinder  
 Rys. 10. Przebiegi ciśnień w komorach lewego siłownika

The diagram of pressure presented in fig. 10 shows that its value is considerably higher than the nominal value which take place at the correct activity of automation control system. It is the result of approach bank bevelling by means of hydraulic cylinders. The pressure at the inlet of directional valve of the left cylinder obtains more than two times higher value in comparison with nominal value in about of the moment  $t_{16}$ .

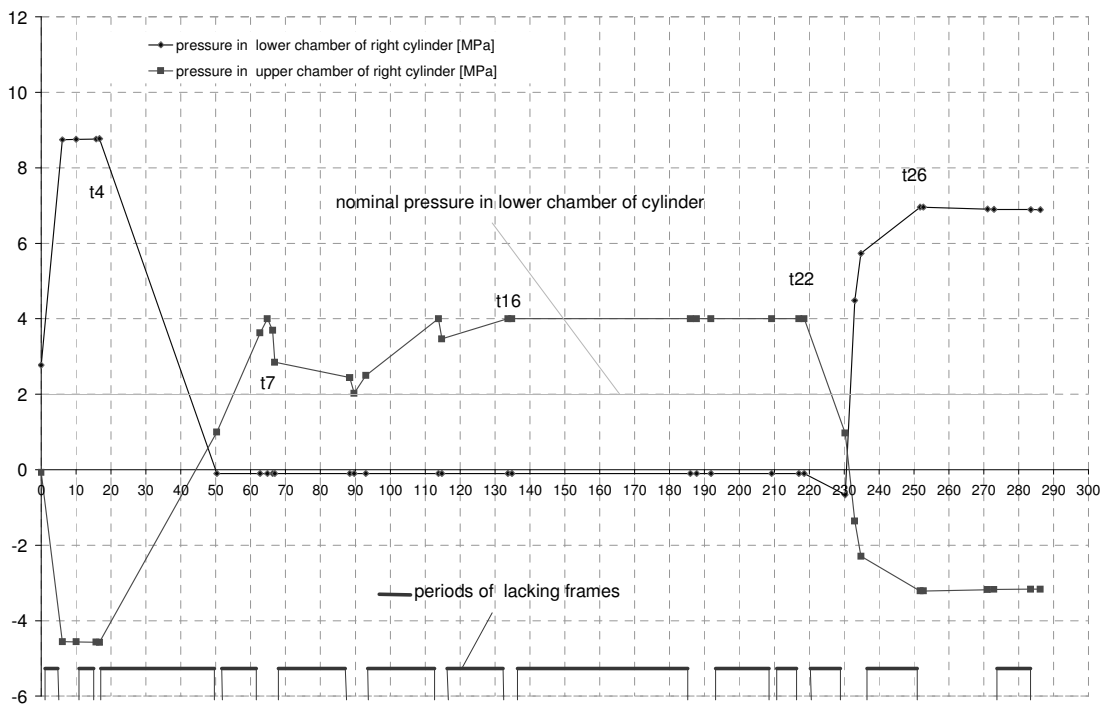
Fig. 11. Diagrams of pressures in chambers of right cylinder  
 Rys. 11. Przebiegi ciśnień w komorach prawego siłownika

Diagrams of pressures show very low energetic efficiency of the system which is seen in the ending phase of analysed period of the movement when the system was normally working as well. The pressure drop obtains the value 12 MPa. The efficiency of the system excluding the pressure drop in hydraulic lines and volumetric loses in the case of the correct work of the system, can be approximately calculated as follow:
